Mulanje Mission Hospital, Malawi, Water Supply Resilience

To Drill, or Not To Drill: That is the question:

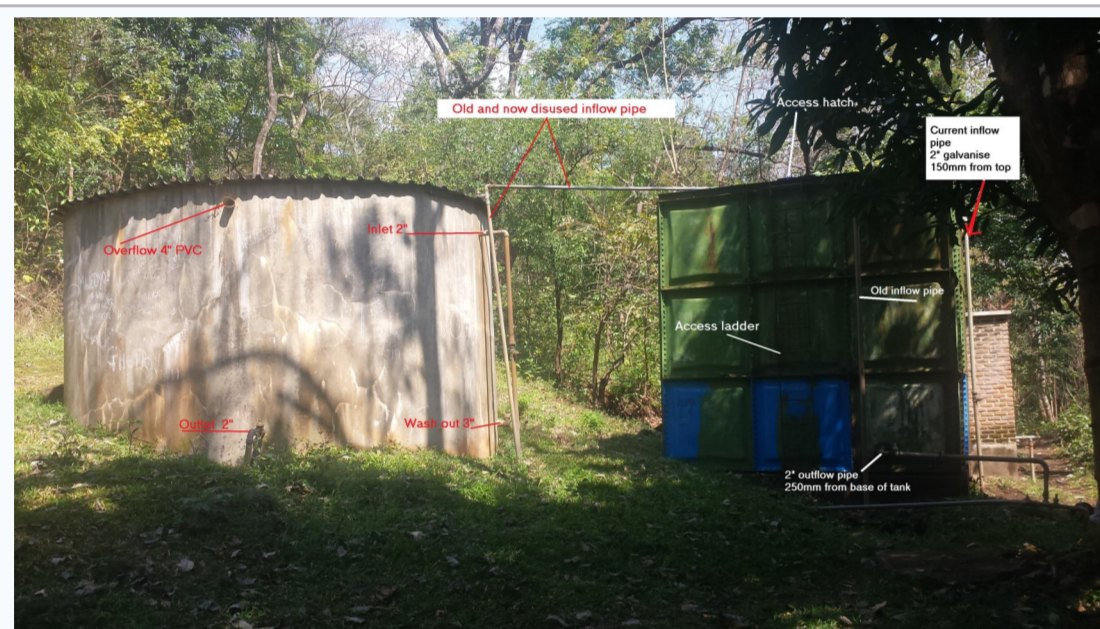
Figure 1: Water Board surface water reservoir (left) & the hospital groundwater reservoir (right) are located on a hill above the hospital. Three 5,000 ltr tanks are located on the hospital grounds (Map 1)

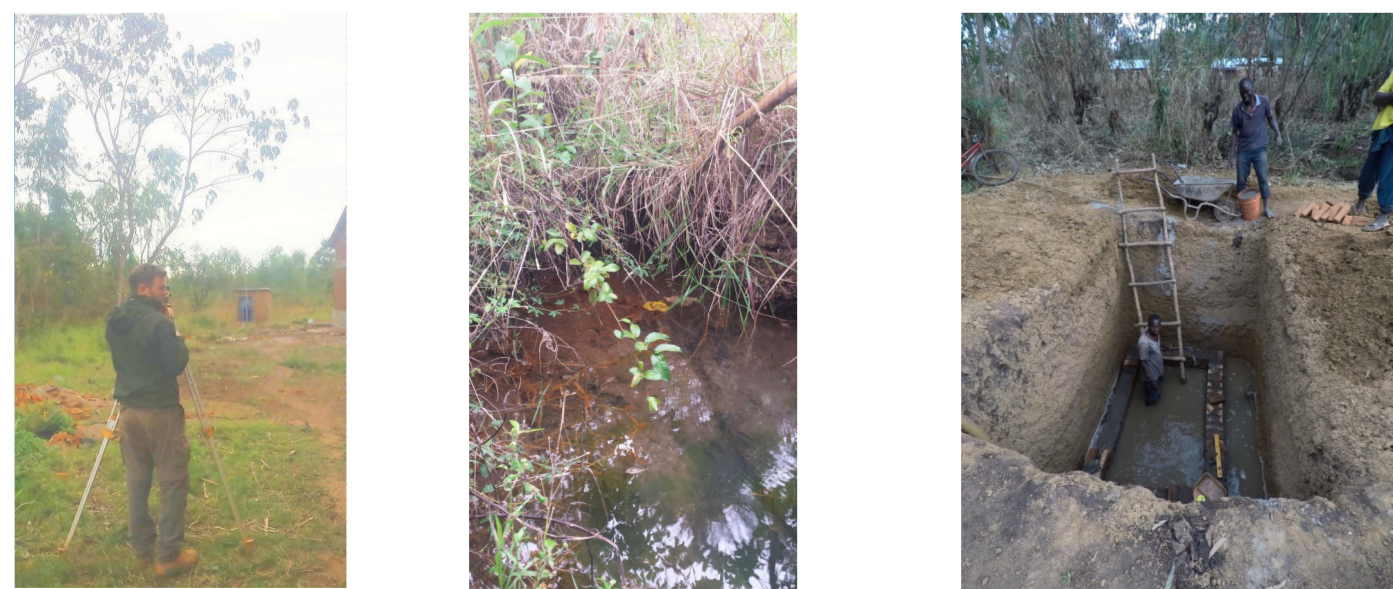
Figures 2 to 4 left to right: investigating the head difference between boreholes and reservoirs (2), and the source of the local watercourse (3) and groundwater contamination sources such as pit latrines (4) (see Map 1).

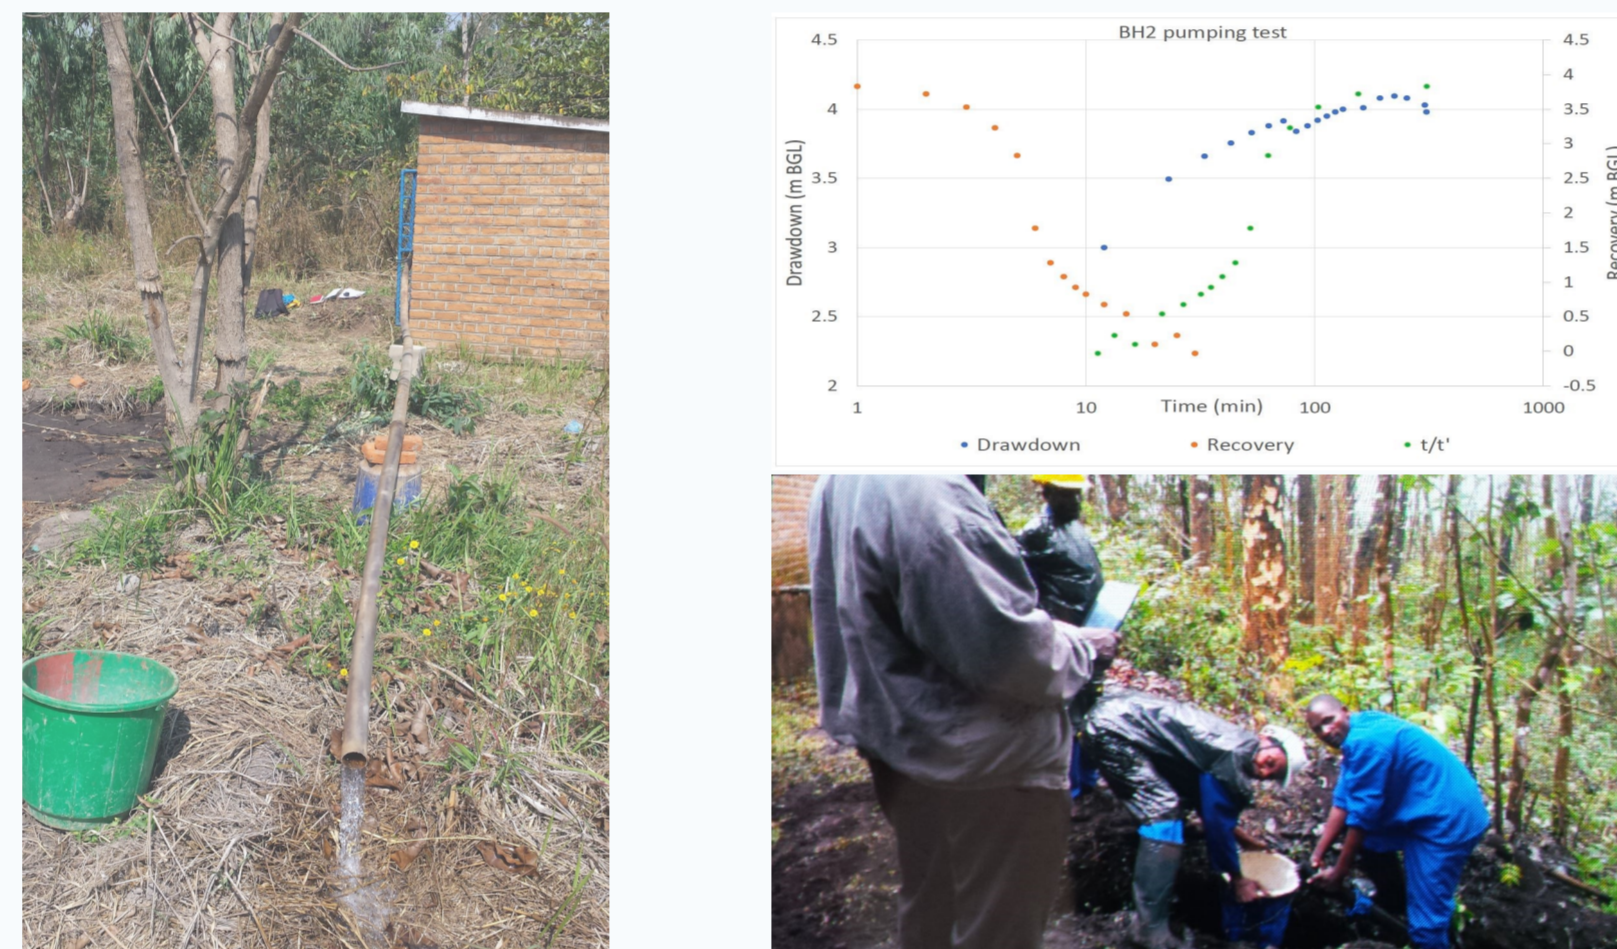
Figure 5 clockwise from the left: the pumping test at BH2; pumping test analysis indicated a transmissivity of 30 m²/d; and measuring the flow rate at the delivery point.

- BH1 and BH2 have an average discharge of 0.6 – 0.8 l/s and 2.0 l/s which indicates that the current BH location area is productive;
- The efficiency of BH1 and BH2 could be improved by replacing inadequately sized fittings at the headworks;
- Several contamination risks (Map 1) will influence the location of the new BHs;
- The Zimba River (Map 1) flows for most of the year and therefore groundwater levels in the area along the river and floodplain are unlikely to drop by a significant amount by the end of the dry season; and
- Most of the local groundwater is found in the top 40 m and the basement rock is very hard to drill.

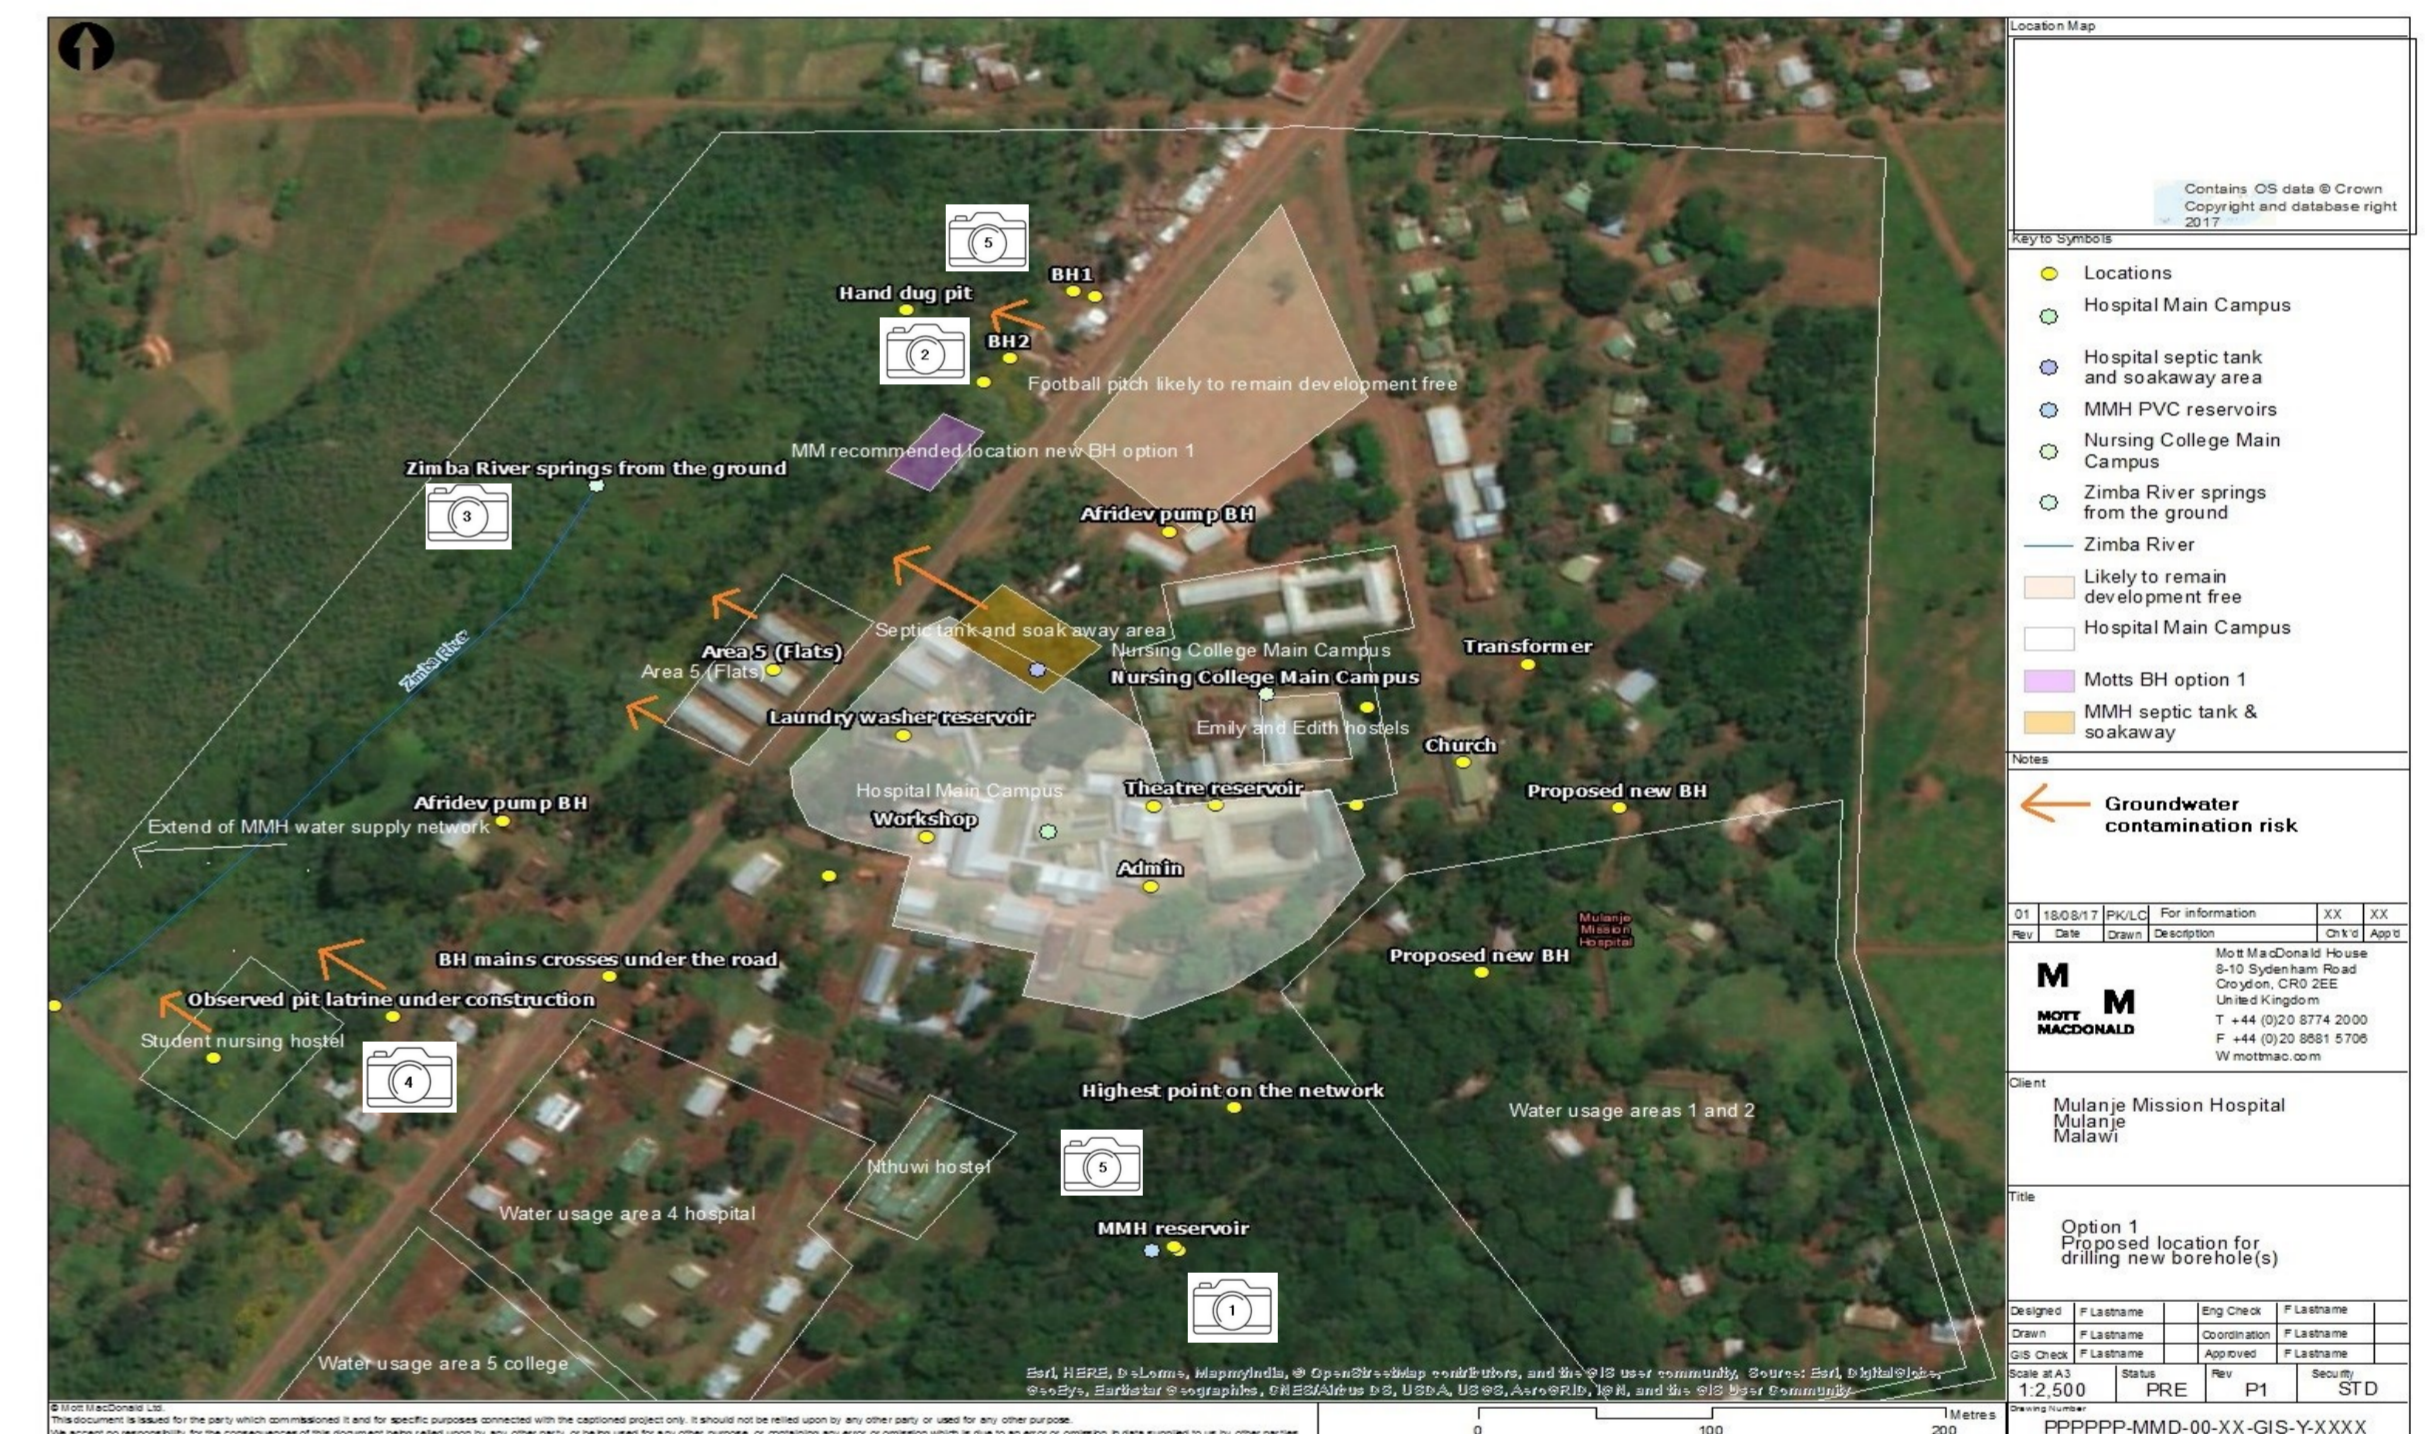
Map 1: the alternative location for drilling the new borehole(s) and the groundwater contamination risks

- Location/depth proposed by the drilling contractor is inadequate because the principal aquifer is in the weathered zone which is likely to be more prominent closer to any geological lines of weakness, such as may occur along the route of surface watercourses, rather than at higher elevations (closer to the reservoirs).
- There is likely to be a greater risk of a lower yield and/or no yield in the dry season.

Drill new borehole(s) to a depth of 40 mBGL to produce an extra 1.0 to 1.5 l/s in the area delineated by the purple polygon (Map 1). Based on the field investigation, this area is at least risk of any significant contamination. The water table will remain high in this area in the dry season.
